Re: M/035/002 – Bingham Canyon Mine  
May 12, 2008 Order Vacating NOV #N2007-58-01  
Waste Rock Stability Study and Results of DAN-W  
Submittal of Revised Documents

This report entitled *Kennecott Utah Copper South Waste Rock Dumps Summary Report* ~~October~~ 2009 has been prepared to fulfil the requirement identified at Page 3, Item c. of the Order Vacating Notice of Violation N2007-58-01 for an off site excursion that occurred in July 2007. Specifically, Item c. states: "Undertake additional modelling and prepare a slope stability study to supplement the existing August 16, 2004 study, and update the 2003 Plan accordingly, as detailed in Attachment 3 to the March 20<sup>th</sup> letter.

This report summarizes a study investigating the long-term stability of the KUC waste rock (WR) dumps. The study goal assimilates the available historical data and begins quantifying the aspects of surface water infiltration, geochemistry and geotechnical conditions that contribute to WR dump stability. This report summarizes primarily information relating to the South End drainages, whose names are shown on Figure 1.

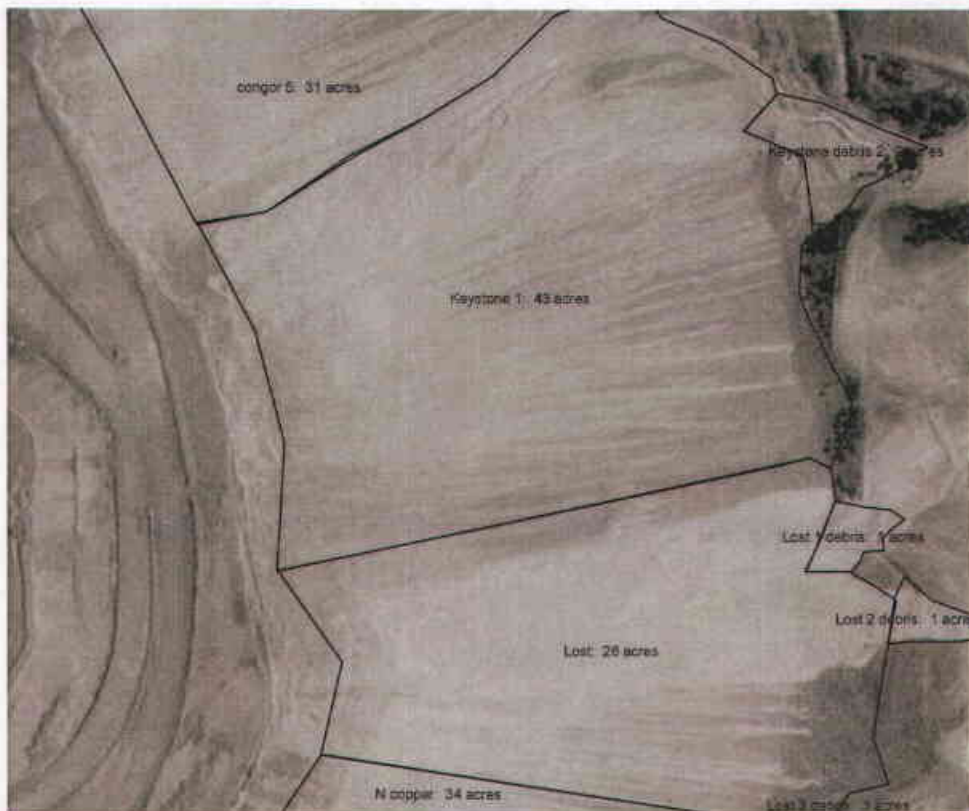
Figure A-7 - The Keystone dump in 1983. Note that minor erosion gullies are already present and previous failure debris has been overtopped.

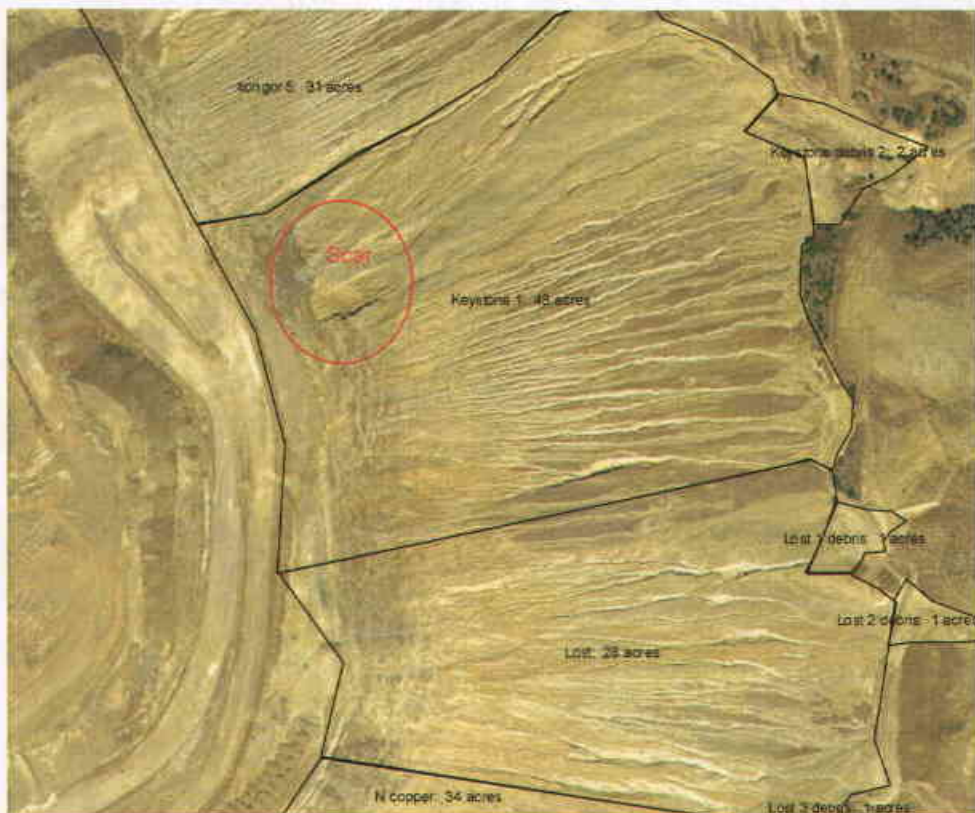
Figure A-8 - Erosion and gullying in 2003 color aerial photograph of same area. Also note the "scar" formed from a debris flow emanating from near the crest (left of the word keystone). The 2006 aerial is not as good quality and is not shown. However, it shows slight enlargement of scar and apparent deepening of the major gullies shown on this photograph. Piles of "plug dump" waste rock are evident in the lower left corner.

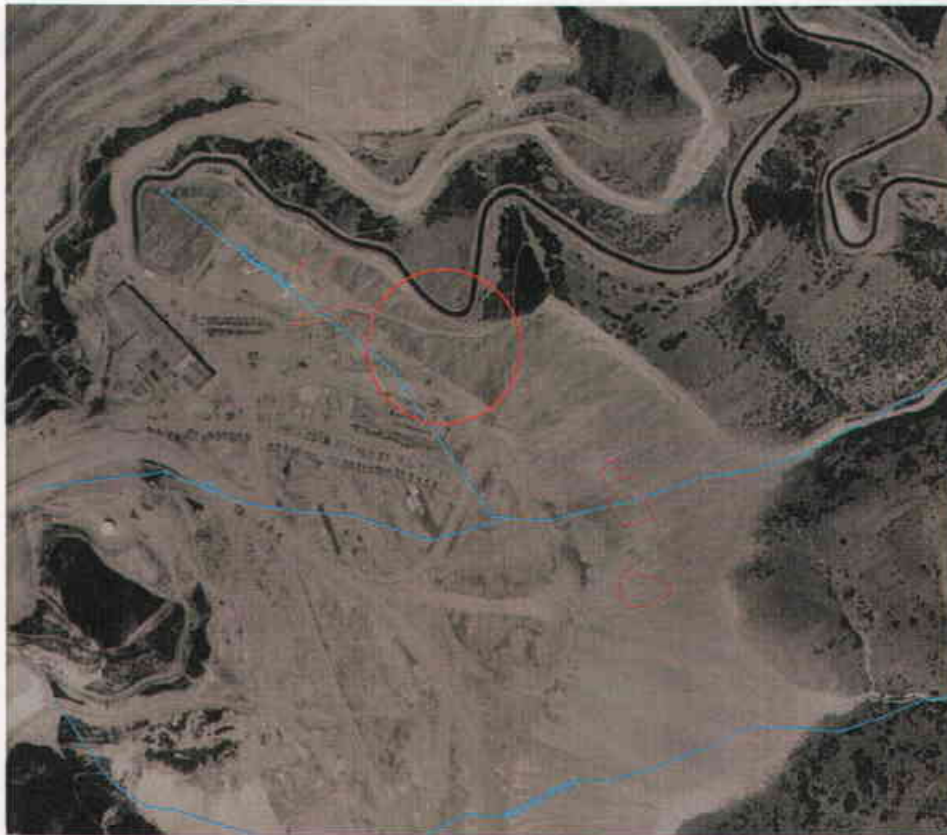
Figure A-9 - 1977 Yosemite aerial photograph. The red circle identifies a major erosion gully.

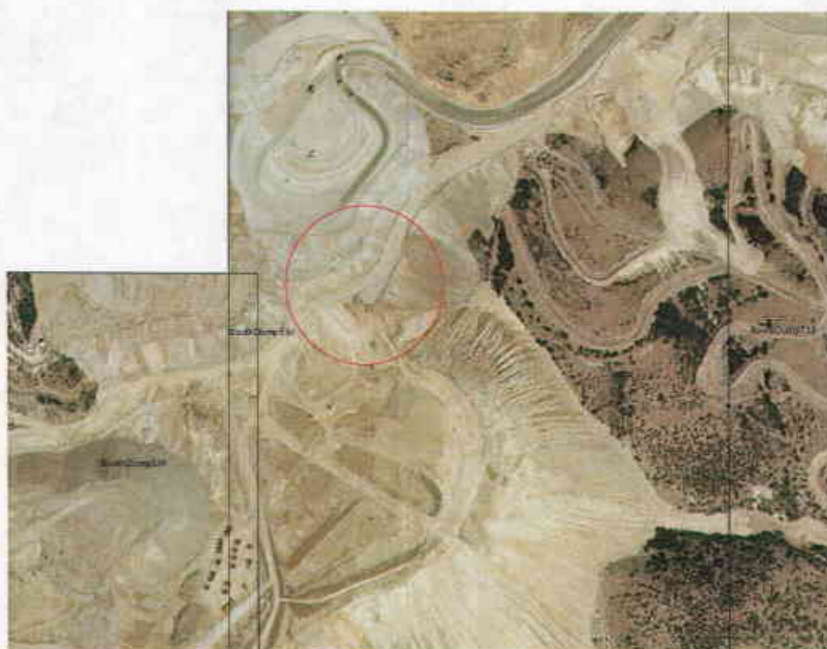
Figure A-13 - 2008 Yosemite Aerial – note how new material has been placed above the large erosional gully that was formerly located within the red circle. This material may have altered the surface drainage on the dump.

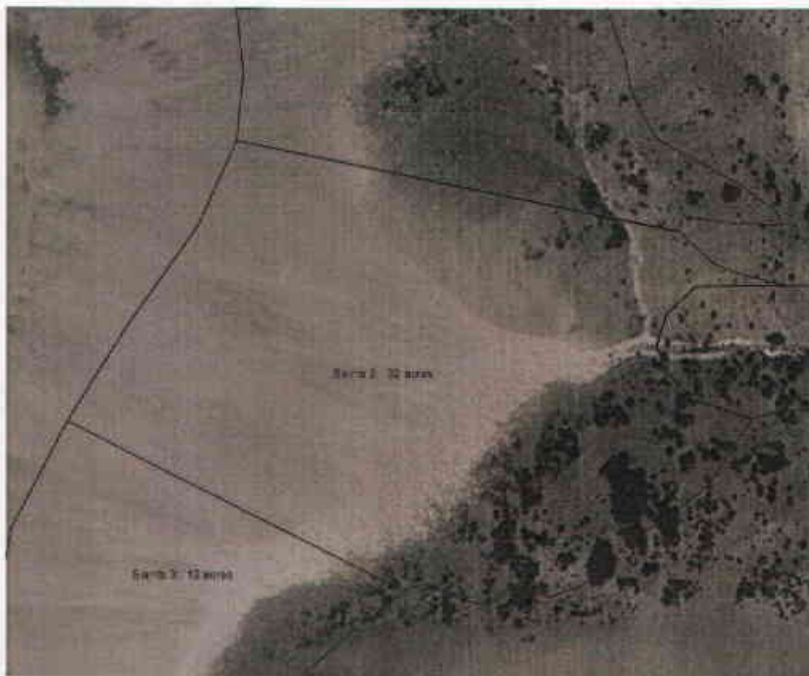
*Figure A-14 - Footprint below the future Saint's rest dump in 1977. This is the area prior to the 1979 failure.*

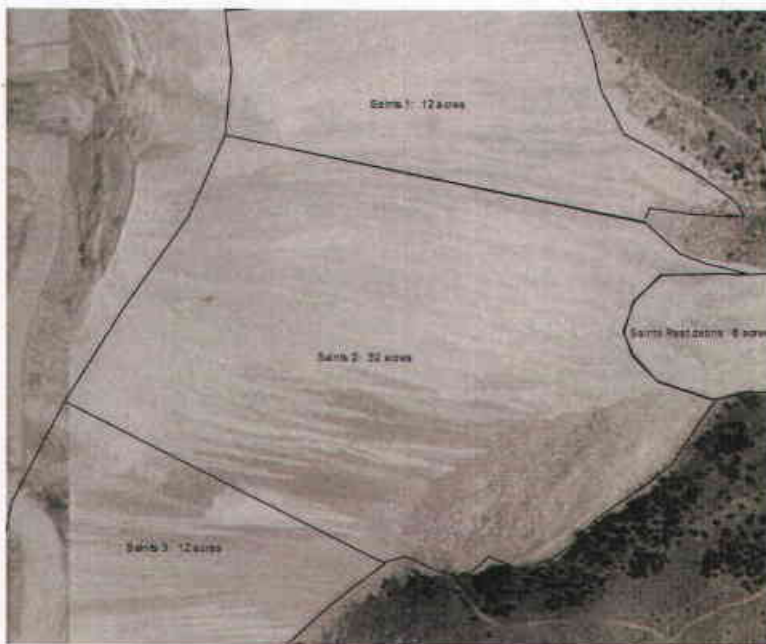
Figure A-15 - The same dump area in 1983. The granular material in the lower (southeast) is the 1979 failure debris.  
Note that minor erosion has begun.

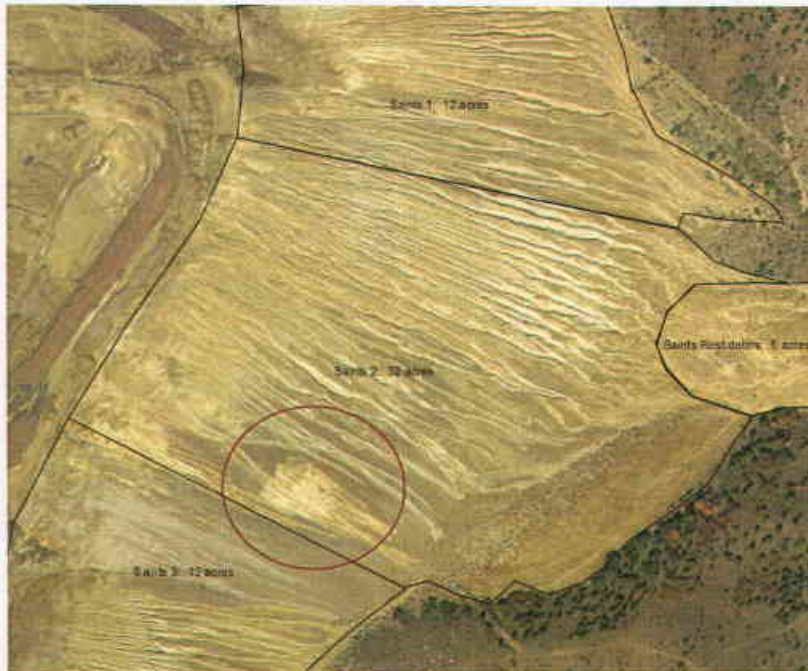
Figure A-16 - Severe erosion and rilling is shown on the 2003 aerial photograph. The red circling area may be indicating seepage from the previous base of the 1979 failure and has been stable since being back filled in 1979. The 2006 aerial photograph is not shown because of quality (albedo) issues.

27	App F Page 31	Figure A-16 indicates a perched table represented by rilling on the south side of Saints 2 approximately 50% of the distance from the toe to the crest. Is there an explanation for the rilling? Is the area a future problem?	Table 2 has been corrected to reflect the correct name of the dump that failed due to leaching in 1979. The rilling appears to be associated with the backfill location of previous 1979 failure. The rilling is most likely due to head cutting, but could be manifestation of perched water table. We do not believe this is a problem because this area has been stable since being backfilled in 1979. Leaching of the South dumps will not be attempted again due to the high calcium content.
28	App F Page 42	It is unclear why figure B-26 was addressed in appendix F and not in Appendix G. This figure is also shown as figure 2 on page 10 of the report.	Figure B-26 was originally in a separate memo. However, the photograph does represent slippage along an infinite slope condition and is now cross referenced. The discussion of the infinite slope condition is "beefed up" with a cross reference to this figure in Appendix G.

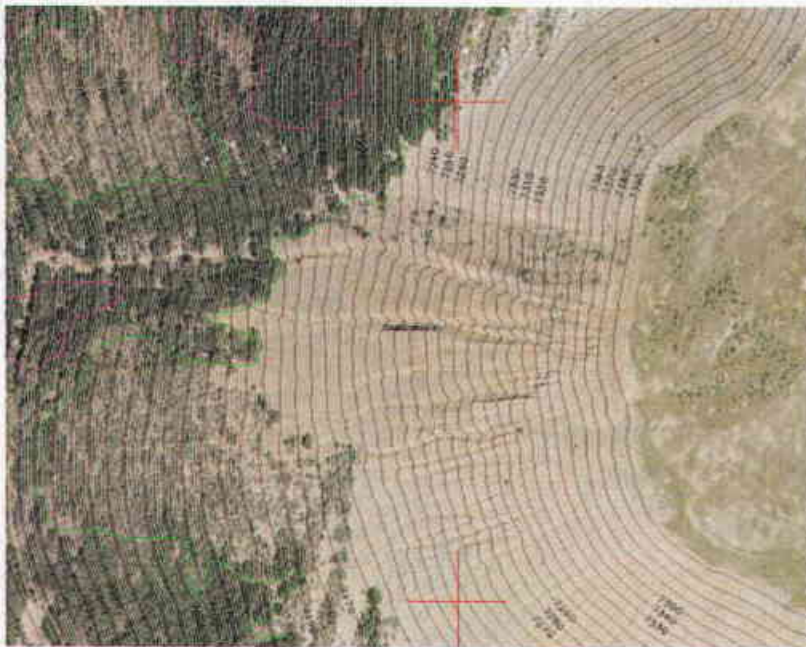
Figure A-17 - Saint's Rest dumps showing areas of concentrated erosion and scarring.

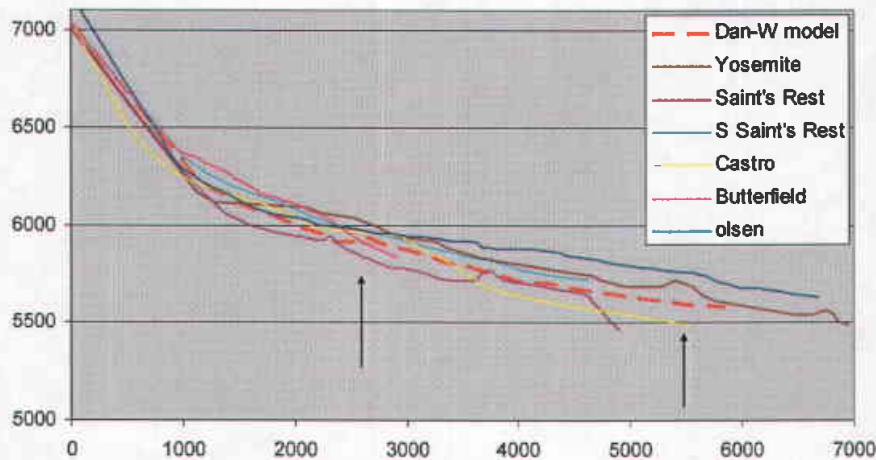
Figure A-18 - Comparison of South End drainage dump profiles

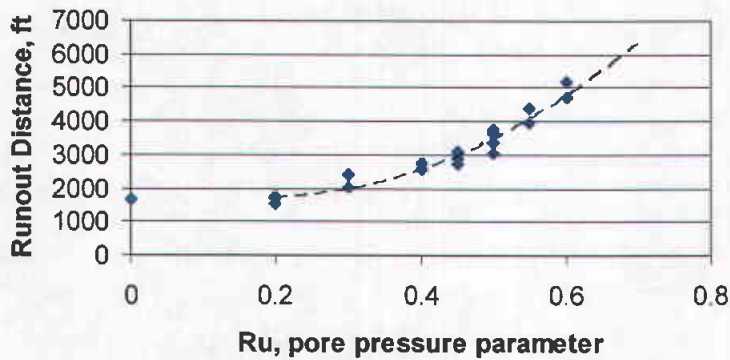
Figure A-19 - Run out distance versus pore pressure parameter,  $R_u$

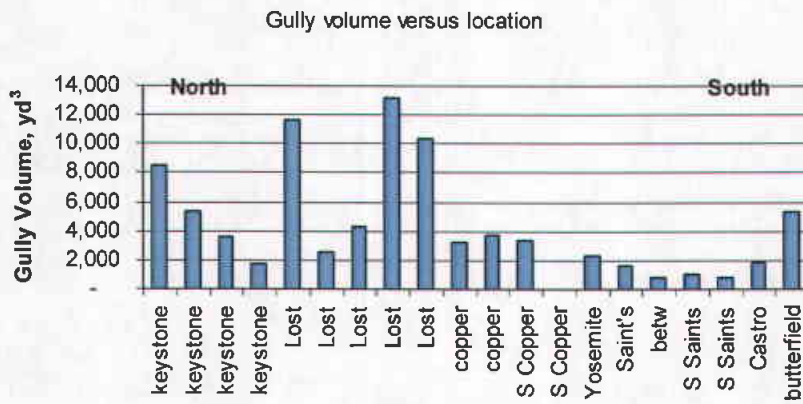
Figure A-20 - Gully volumes

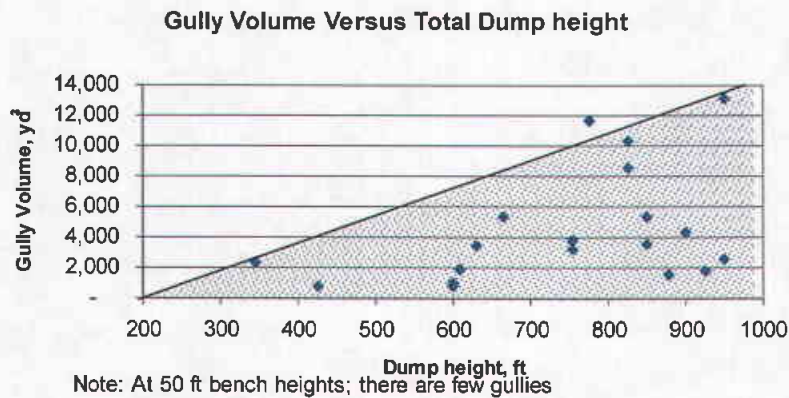
Figure A-21 - Relationship between dump height and maximum volume of gullies measured from aerial photography

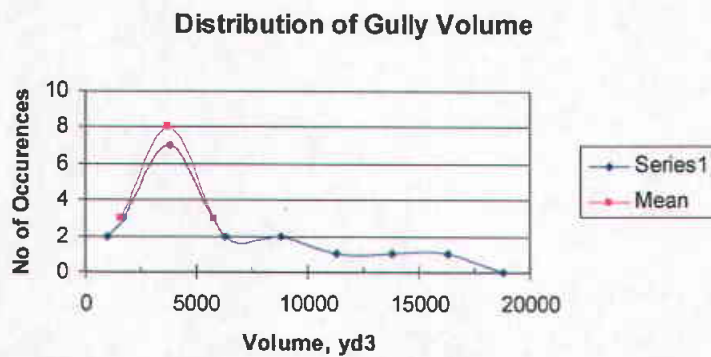
Figure A-22 - Distribution of gully sizes. The mean values shown are the mean and standard deviation of the gullies less than 7500 yd<sup>3</sup> in volume.

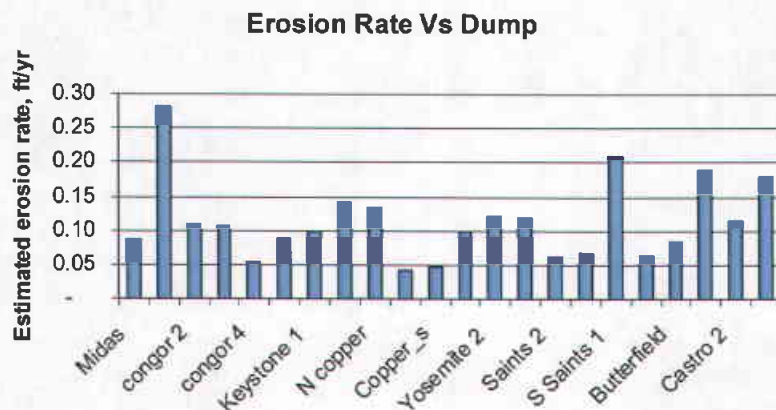
Figure A-24 - Approximate erosion rates by dump area

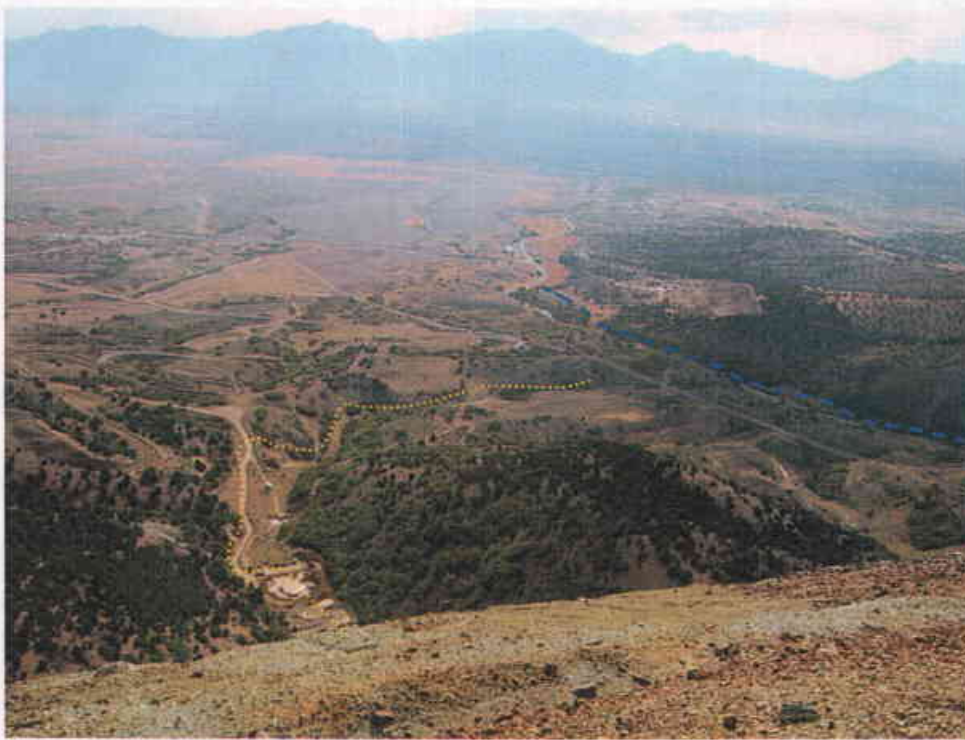
Figure B-25 - View eastward and downward from the Yosemite dump crest. The approximate path of the debris flow is indicated in yellow, along with location of Butterfield Creek by the blue line.

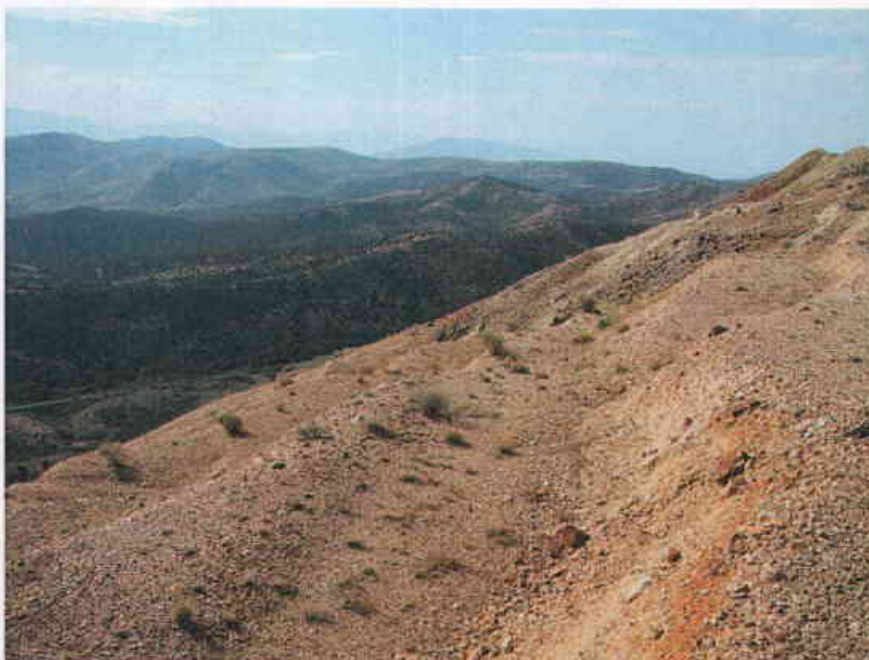
*Figure B-26 - View of settlement cracks / surficial movement at crest of dump. There is abundant evidence that shallow slips of the surface continue to occur. Tension cracks are sometimes observed as far back as 500 feet from crest. Cracks tend to "heal" themselves over time (close up). Survey monuments situated up slope of these cracks settled 3 ½ to 4 ½ inches from Oct 2005 to April 2007. This is less than the 6 inches of average settlement during the period. Displacement along these scarps is obviously much greater and on the order of feet. It is also possible that this terraced topography is reducing over-land flow velocities so that gulying and erosion does not occur at the dump crest.*

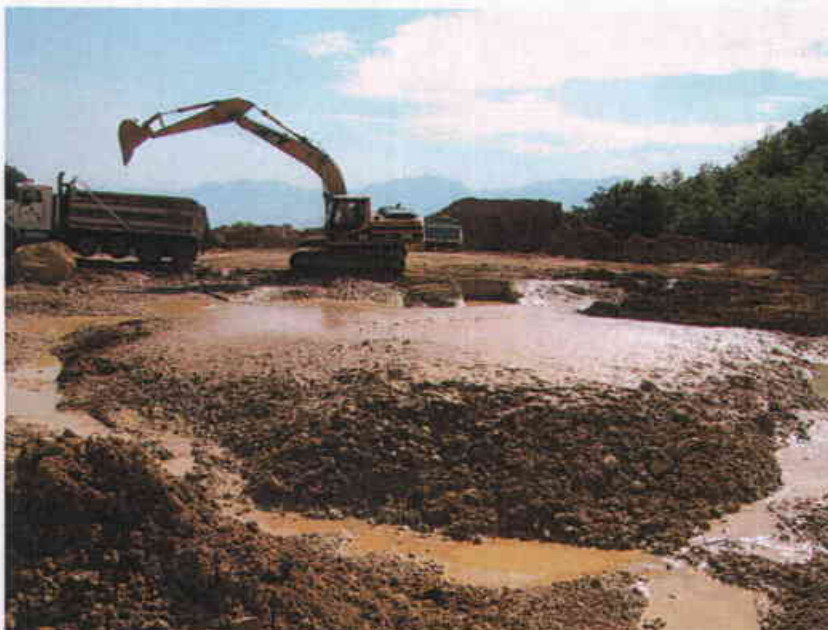
Figure B-27 - Debris flow material in basin up slope of the east side collection cut off wall. Material is a classic debris flow, consisting of viscous gravel, sand, silt and clay. The majority of the coarse particles were contained within the basin.

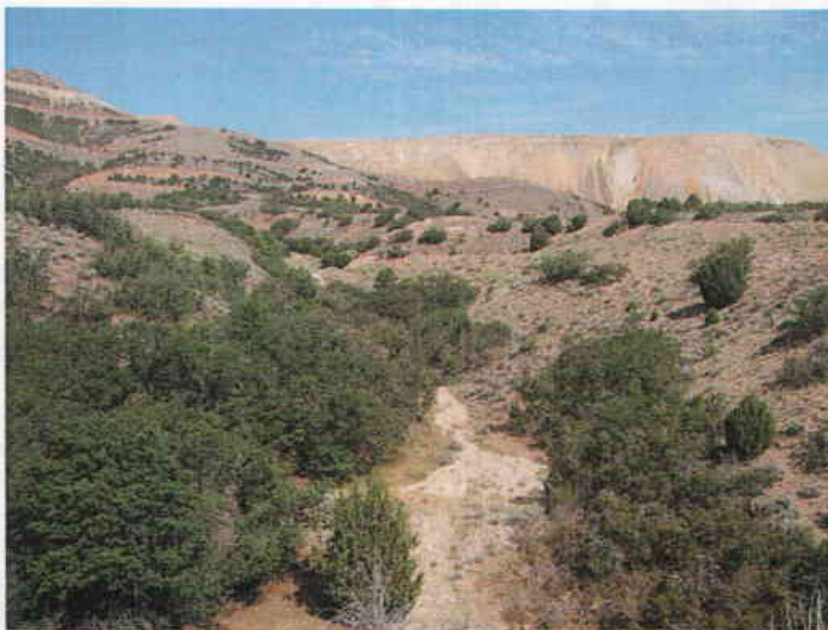
Figure B-28 - View from embankment supporting the east side collection pipeline. At this point, the debris flow only transported the finer grain size sand, silt and clay. Some of this material was transported through a culvert at the base of the embankment toward Butterfield Creek.

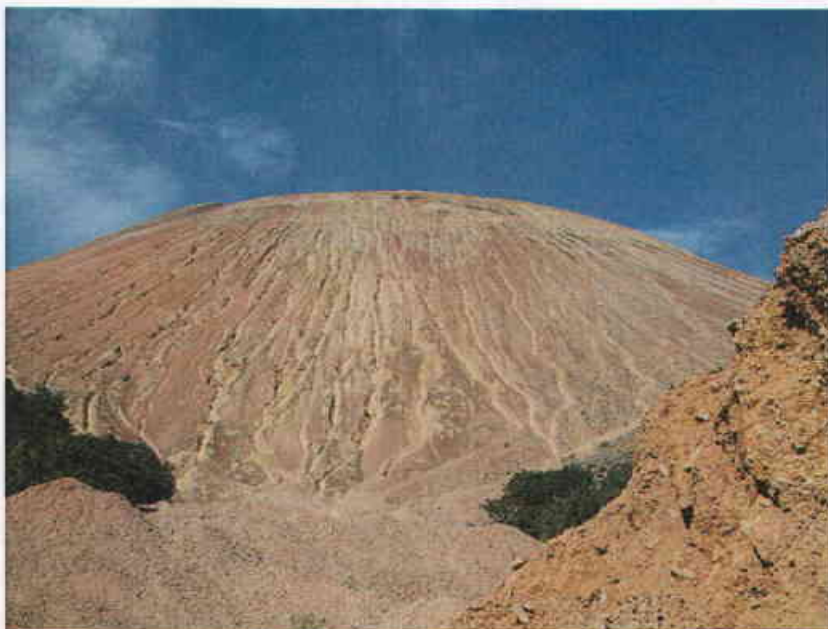
*Figure B-29 - Erosion gullies and rills extending down the face of the gulch. The gullies and rills generally do not extend to the dump crest, rather begin about 10 to 20 percent down the face of the dump.*

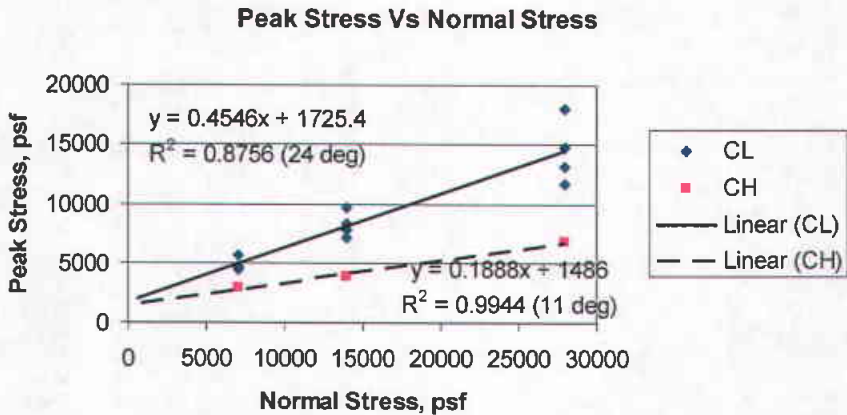
Figure G-1 - Foundation Clay shear strength test data (see discussion in Appendix A)

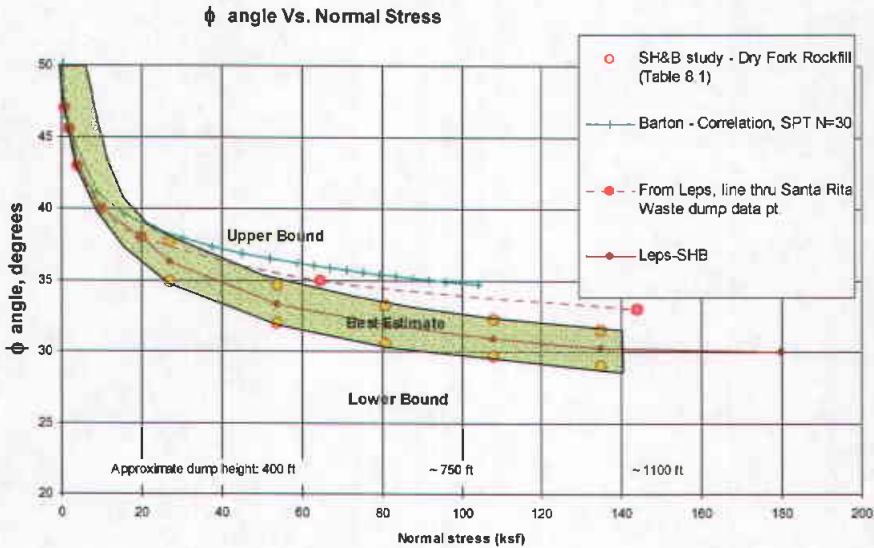
Figure G-2 - Waste rock shear strength envelopes (see discussion in Appendix B).
